# Carrier 19C 1200 ton Centrifugal Chiller Repair Case Study

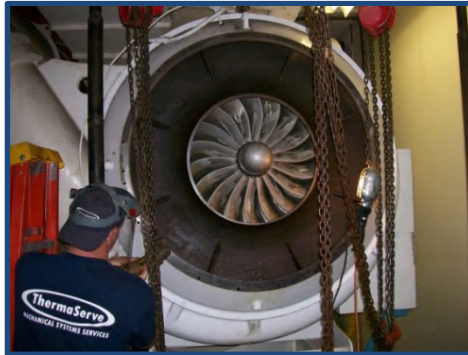
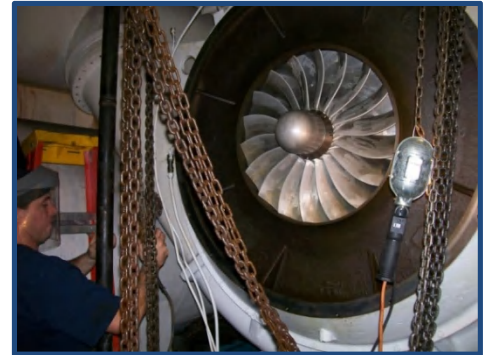
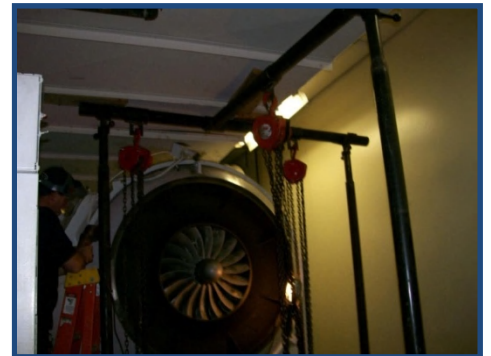
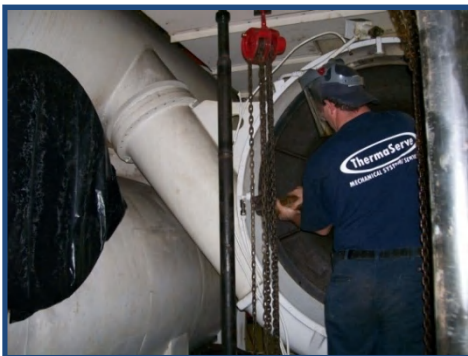
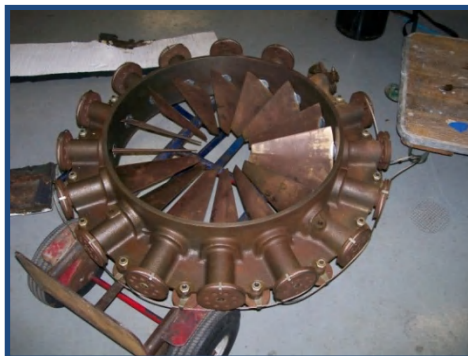
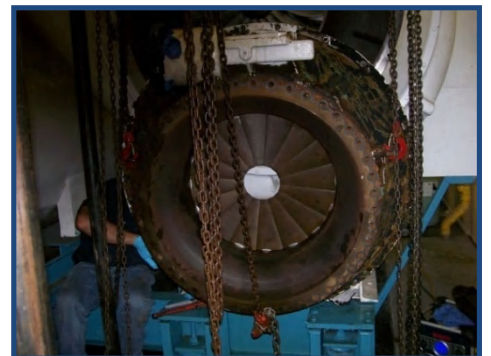
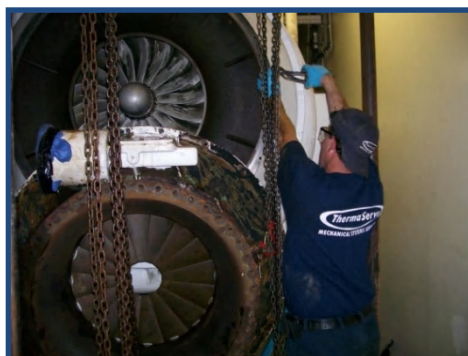
Inlet guide vanes were seized

No room for rigging and had to custom build a gantry to rig

Machines have to be repaired in place because they are located on the 36<sup>th</sup> floor
