### Thinking Outside the Box in Real Time

by Marty Gilliam

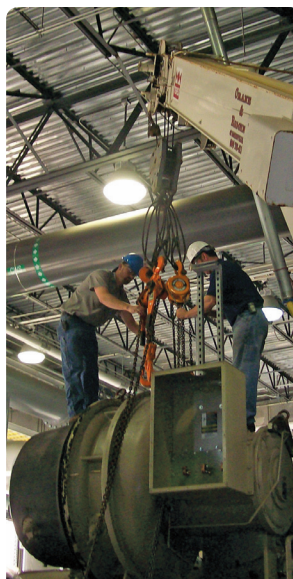
Contractors are often under a great deal of pressure to complete jobs faster, and at a lower cost. One case in point was a call we received to repair a leaking discharge flange o-ring on a large tonnage (1,500 tons) low pressure chiller. This would ordinarily require a complete teardown. Teardowns are very labor intensive and time consuming. Hundreds of bolts must be removed and re-installed. Multiple, precise measurements within thousandths of an inch have to be obtained. Finally, there's the cleaning of multiple-mating surfaces, o-rings, and gaskets to replace.

**Solution:** A plan was devised to lift the compressor assembly up about 18-in. to replace the failed o-ring. The first challenge was finding a crane small enough to fit into the mechanical room, yet be capable of accomplishing the lift. Then, the lifting brackets had to be custom-made at a local machine shop. Some modifications had to be made to the lifting brackets, to ensure a secure fit for the

2. After the compressor castings were carefully drilled and pinned, the crane and rigging was put in place for the big lift. The boom was placed over the center of gravity point of the compressor/motor assembly, and remained stationary, so that the lift could be controlled more precisely with the chain falls (see photo above).

3. Once the compressor was suspended in mid air, the failed o-ring was replaced.
